Flood Control Project Maintenance
2019 Structure Summary Report
Overall Unit and Item Ratings

DWR Sacramento Maintenance Yard

Cache Creek Settling Basin Weir And Drainage Structure

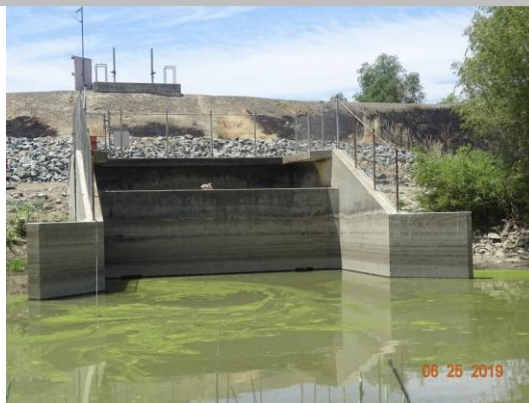
Photo 1 of 4 : ST_2019_NA0055_12_24_20190730_00023.jpg

View of outlet structure. Summer 2019.

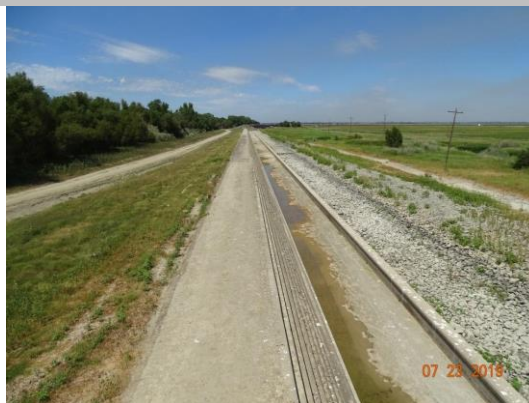
Photo 2 of 4 : ST_2019_NA0055_12_24_20190730_00024.jpg

View of weir from the South abutment. Summer 2019.

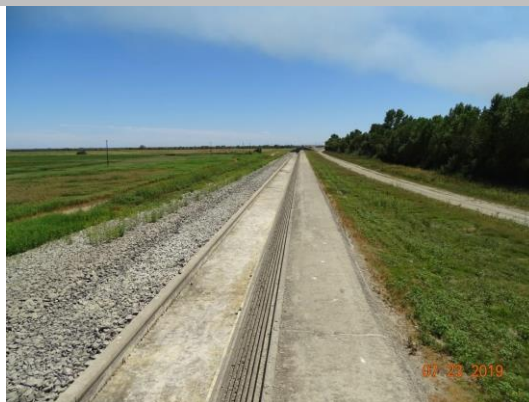
Photo 3 of 4 : ST_2019_NA0055_12_24_20190730_00025.jpg

View of the weir from the North abutment. Summer 2019.

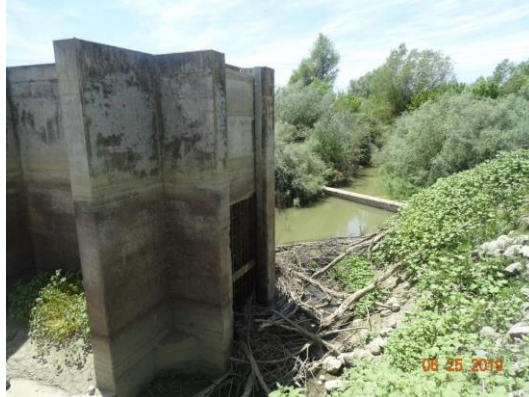
Photo 4 of 4 : ST_2019_NA0055_12_24_20190730_00026.jpg

View of inlet structure. Summer 2019.

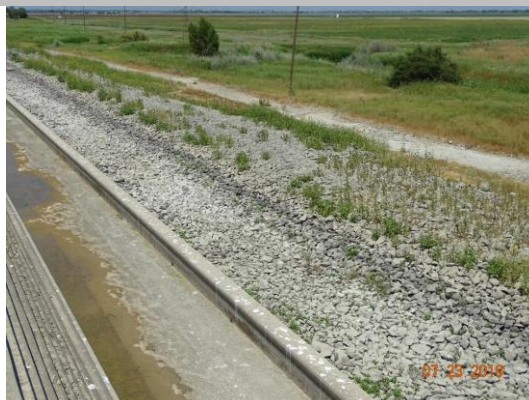
Photo 1 of 1 : ST_2019_NA0055_12_5_20190724_00015.jpg

View of the riprap adjacent to the stilling basin. Summer 2019.

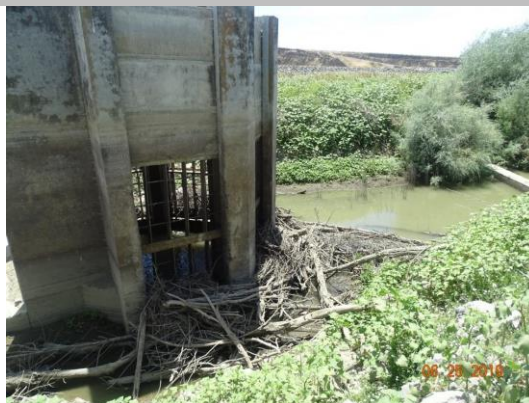
Photo 1 of 2 : ST_2019_NA0055_12_7_20190725_00016.jpg

View of debris at the low-flow channel inlet. Summer 2019.

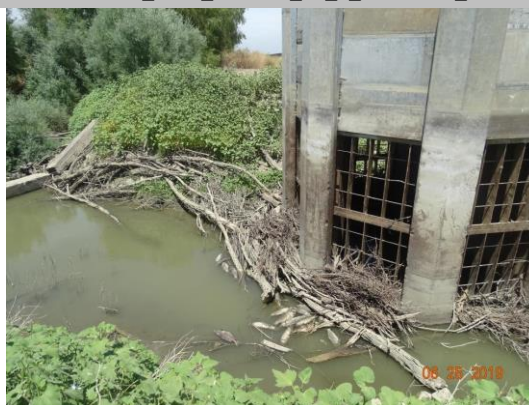
Photo 2 of 2 : ST_2019_NA0055_12_7_20190725_00017.jpg

Additional view of the debris. Summer 2019.

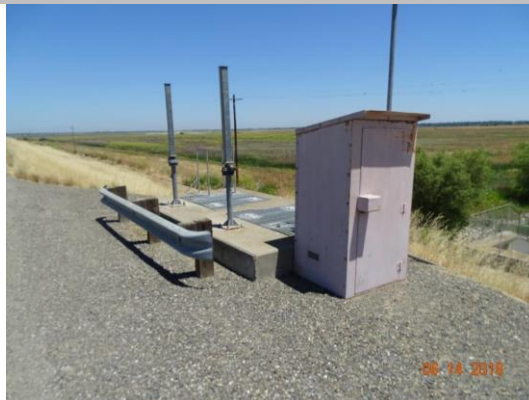
Photo 1 of 1 : ST_2019_NA0055_12_14_20190625_00005.jpg

LM Start	0.00	Rating **	A	Issue No.	14
LM End	0.00	Issue Type +	Ma	Location *	CR
Category	Structures & Concrete Lined Channels	GPS Latitude/Longitude			
		Start		End	
Item	Manual Gate Operators	38.682460 °		38.687350 °	
		-121.672930 °		-121.673740 °	
DWR ID	DWR_NA0055_12_t_2012_14				
Action/Comments					
Inspector Comments: The gate operators are in good working condition.

View of the gate operators to the drainage structure. Summer 2018.

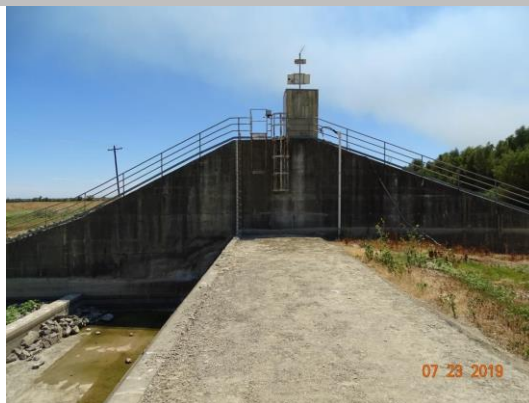
Photo 1 of 5 : ST_2019_NA0055_12_15_20190725_00018.jpg

LM Start	0.00	Rating **	A	Issue No.	15
LM End	0.00	Issue Type +	Ma	Location *	CR
Category	Structures & Concrete Lined Channels			GPS Latitude/Longitude	
				Start	End
Item	Concrete Surfaces			38.682460 °	38.687350 °
				-121.672930 °	-121.673740 °
DWR ID	DWR_NA0055_12_t_2012_15				
Action/Comments					
Inspector Comments: Negligible spalling and cracking. Cracks should be sealed to prevent freeze/thaw damage.

View of south weir abutment. Summer 2019.

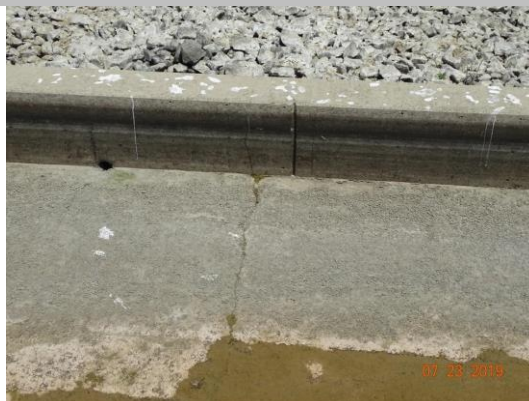
Photo 2 of 5 : ST_2019_NA0055_12_15_20190725_00019.jpg

View of minor cracking within the stilling basin. Summer 2019.

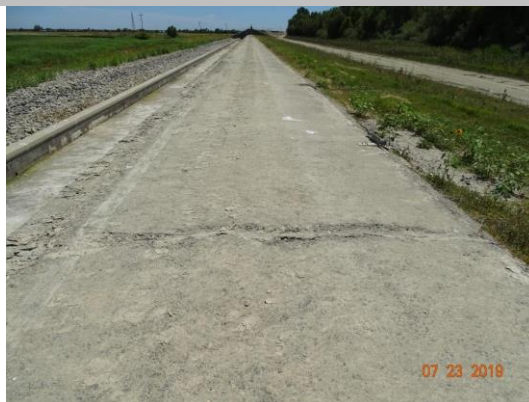
Photo 3 of 5 : ST_2019_NA0055_12_15_20190725_00020.jpg

View of patched crack on weir apron. Summer 2019.

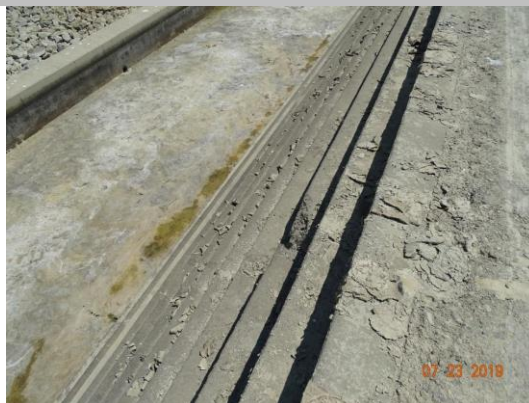
Photo 4 of 5 : ST_2019_NA0055_12_15_20190725_00021.jpg

LM Start	0.00	Rating **	A	Issue No.	15 (cont)
LM End	0.00	Issue Type +	Ma	Location *	CR
Category	Structures & Concrete Lined Channels			GPS Latitude/Longitude	
				Start	End
Item	Concrete Surfaces			38.682460 °	38.687350 °
				-121.672930 °	-121.673740 °
DWR ID	DWR_NA0055_12_t_2012_15				
Action/Comments					
Inspector Comments: Negligible spalling and cracking. Cracks should be sealed to prevent freeze/thaw damage.

View of spalling on the weir steps. Summer 2019.

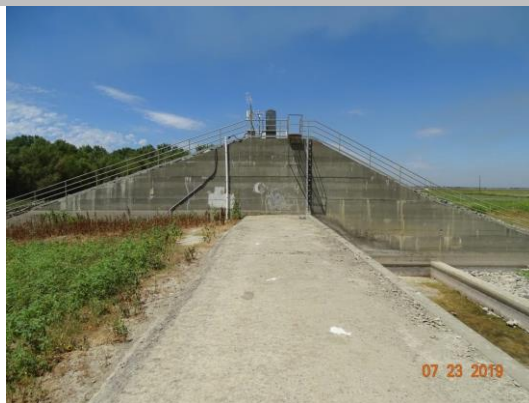
Photo 5 of 5 : ST_2019_NA0055_12_15_20190725_00022.jpg

View of the north weir abutment. Summer 2019.

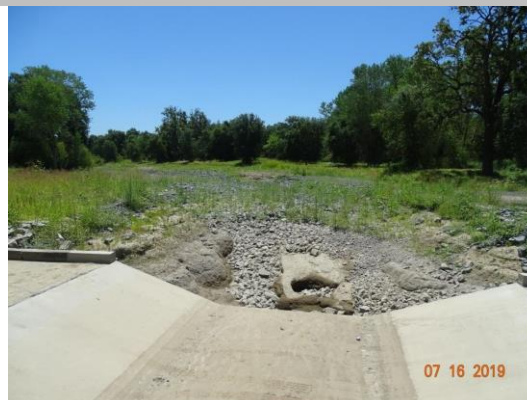
Photo 1 of 1 : ST_2019_NA0055_2_4_20190717_00040.jpg

LM Start	0.00	Rating **	M	Issue No.	4
LM End	0.00	Issue Type +	Ma	Location *	CR
Category	Structures & Concrete Lined Channels			GPS Latitude/Longitude	
				Start	End
Item	Erosion / Bank Caving			38.758880 °	38.764680 °
				-121.665380 °	-121.635430 °
DWR ID	DWR_NA0055_2_t_2012_4				
Action/Comments					
Inspector Comments: Some active erosion on the downstream end of the new fish passage structure. DOE confirmed that they will repair prior to October 31, 2019.

View of the erosion on the downstream end of the fish passage structure. Summer 2019.

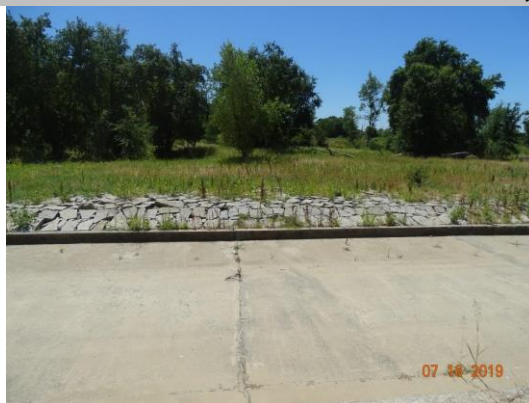
Photo 1 of 1 : ST_2019_NA0055_2_5_20190717_00030.jpg

LM Start	0.00	Rating **	A	Issue No.	5
LM End	0.00	Issue Type +	Ma	Location *	CR
Category	Structures & Concrete Lined Channels	GPS Latitude/Longitude			
		Start		End	
Item	Revetments	38.758880 °		38.764680 °	
		-121.665380 °		-121.635430 °	
DWR ID	DWR_NA0055_2_t_2012_5				
Action/Comments					
Inspector Comments: Riprap is in good condition.

View of the revetment along the weir. Summer 2019.

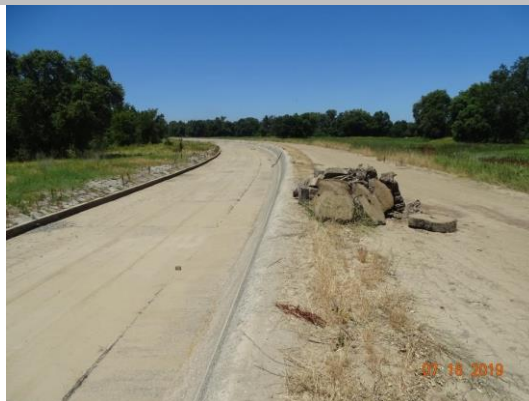
Photo 1 of 1 : ST_2019_NA0055_2_6_20190717_00020.jpg

LM Start	0.00	Rating **	A	Issue No.	6
LM End	0.00	Issue Type +	Ma	Location *	CR
Category	Structures & Concrete Lined Channels	GPS Latitude/Longitude			
		Start		End	
Item	Encroachments	38.758880 °		38.764680 °	
		-121.665380 °		-121.635430 °	
DWR ID	DWR_NA0055_2_t_2012_6				
Action/Comments					
Inspector Comments: Some wood piles along the weir. They will not impede the flow, but should be removed.

View of wood pile. Summer 2019.

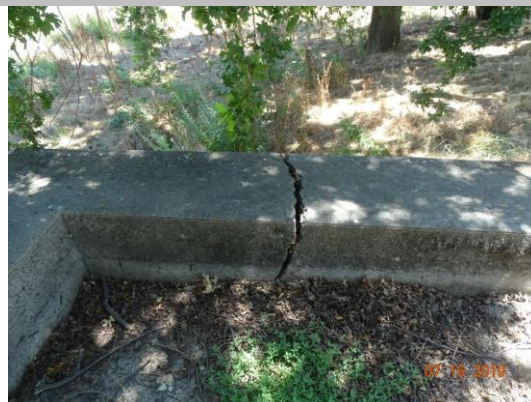
Photo 1 of 6 : ST_2019_NA0055_2_15_20190717_00036.jpg

LM Start	0.00	Rating **	A	Issue No.	15
LM End	0.00	Issue Type +	Ma	Location *	CR
Category	Structures & Concrete Lined Channels	GPS Latitude/Longitude			
		Start		End	
Item	Concrete Surfaces	38.758880 °		38.764680 °	
		-121.665380 °		-121.635430 °	
DWR ID	DWR_NA0055_2_t_2012_15				
Action/Comments					
Inspector Comments: Large crack on the west weir abutment. Minor spalling on the weir wall. A new fish passageway within the weir was constructed.

View of the crack on the west abutment. Summer 2019.

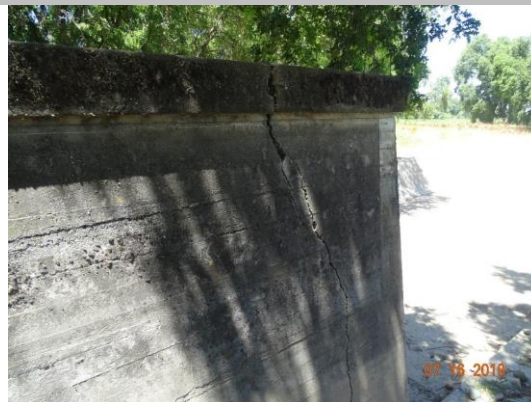
Photo 2 of 6 : ST_2019_NA0055_2_15_20190717_00037.jpg

Additional view of the crack on the west abutment. Summer 2019.

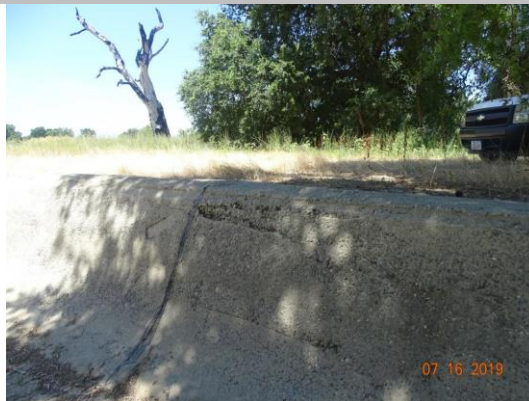
Photo 3 of 6 : ST_2019_NA0055_2_15_20190717_00039.jpg

LM Start	0.00	Rating **	A	Issue No.	15 (cont)
LM End	0.00	Issue Type +	Ma	Location *	CR
Category	Structures & Concrete Lined Channels	GPS Latitude/Longitude			
		Start		End	
Item	Concrete Surfaces	38.758880 °		38.764680 °	
		-121.665380 °		-121.635430 °	
DWR ID	DWR_NA0055_2_t_2012_15				
Action/Comments					
Inspector Comments: Large crack on the west weir abutment. Minor spalling on the weir wall. A new fish passageway within the weir was constructed.

View of spalling on the weir near the midpoint. Summer 2019.

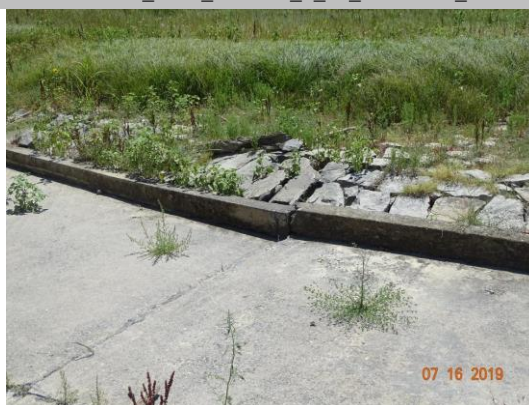
Photo 1 of 1 : ST_2019_NA0055_2_16_20190717_00038.jpg

LM Start	0.00	Rating **	M	Issue No.	16
LM End	0.00	Issue Type +	Ma	Location *	CR
Category	Structures & Concrete Lined Channels	GPS Latitude/Longitude			
		Start		End	
Item	Concrete Tilting / Settlement	38.758880 °		38.764680 °	
		-121.665380 °		-121.635430 °	
DWR ID	DWR_NA0055_2_t_2012_16				
Action/Comments					
Inspector Comments: There are some low spots at the stilling basin of the weir that do not threaten the integrity of the structure.

Minor settlement on the stilling basin of the weir. Summer 2019.

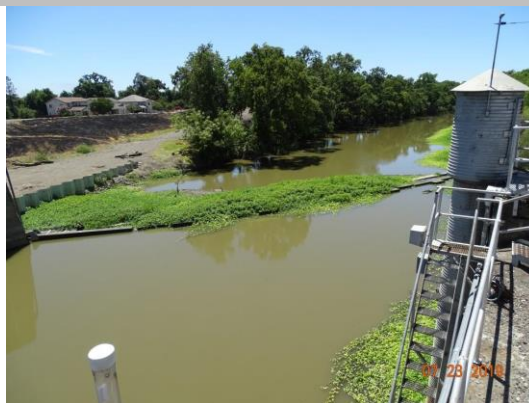
Photo 2 of 2 : ST_2019_NA0055_41_2_20190730_00015.jpg

View of the accumulated vegetation on the log boom. Summer 2019.

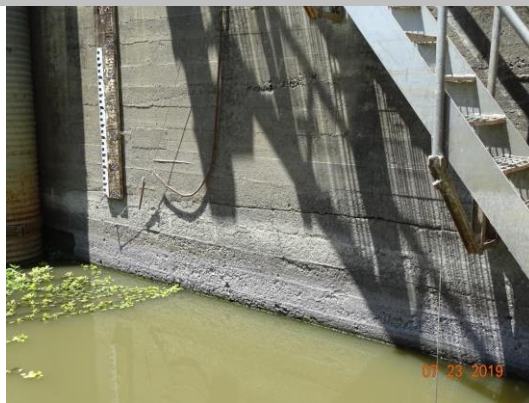
Photo 1 of 1 : ST_2019_NA0055_41_15_20190730_00022.jpg

Minor cracking on the north abutment. Summer 2019.

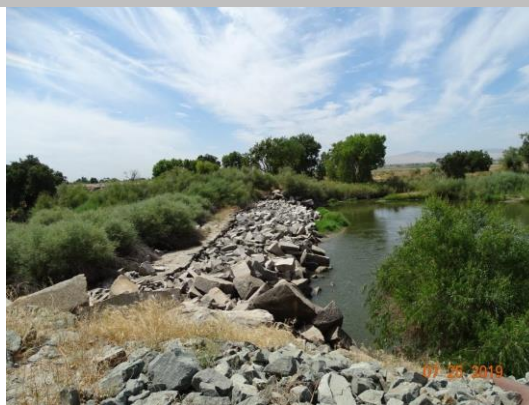
Photo 1 of 2 : ST_2019_NA0055_52_2_20190730_00009.jpg

View of vegetation on the riverside side of structure, looking westward.
Summer 2019

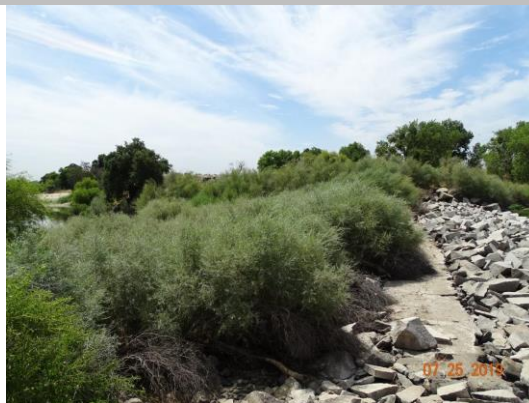
Photo 2 of 2 : ST_2019_NA0055_52_2_20190730_00011.jpg

View of vegetation on the riverside of structure, looking westward.
Summer 2019

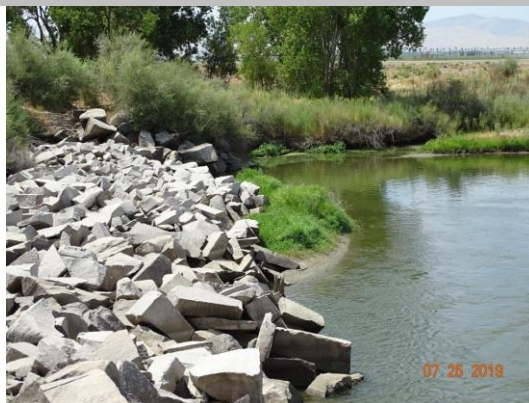
Photo 1 of 2 : ST_2019_NA0055_52_3_20190730_00012.jpg

View of sedimentation on channel side of dam. Summer 2019

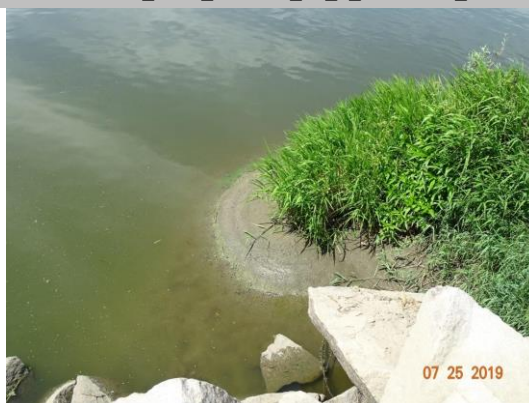
Photo 2 of 2 : ST_2019_NA0055_52_3_20190730_00014.jpg

View of sedimentation on channel side of dam. Summer 2019

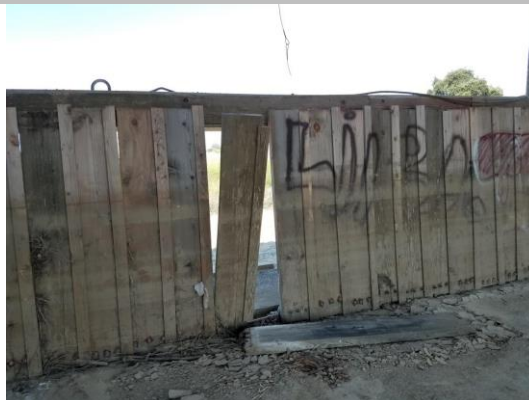
Photo 1 of 2 : ST_2019_NA0055_1_12_20190708_00038.jpg

View of broken needles in bay 3. Summer 2019.

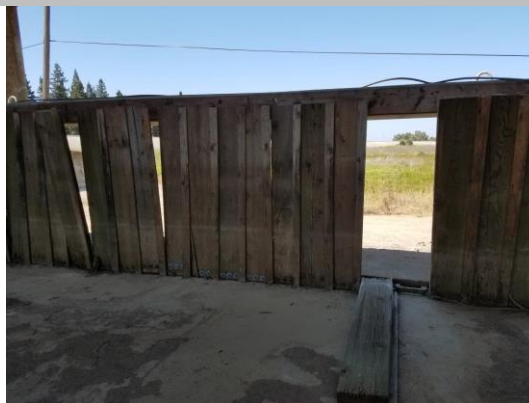
Photo 2 of 2 : ST_2019_NA0055_1_12_20190708_00039.jpg

View of broken needles in bay 38. Summer 2019.

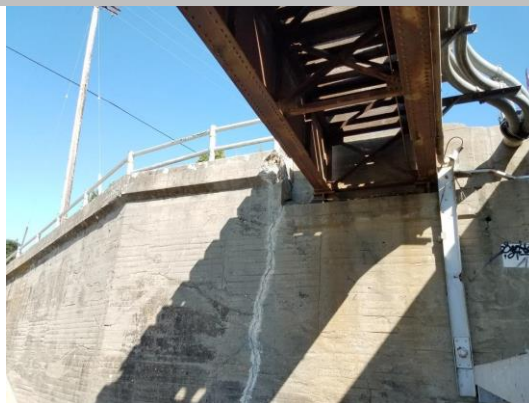
Photo 1 of 8 : ST_2019_NA0055_1_15_20190708_00025.jpg

View of crack and spalling in bay 1. Summer 2019.

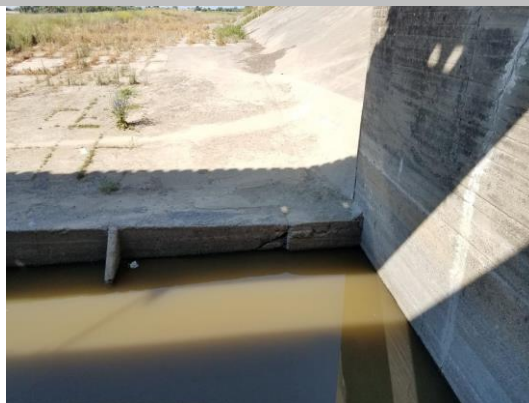
Photo 2 of 8 : ST_2019_NA0055_1_15_20190708_00026.jpg

View of exposed rebar in bay 1. Summer 2019.

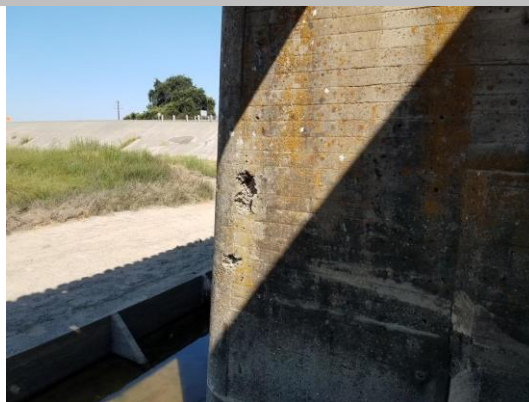
Photo 3 of 8 : ST_2019_NA0055_1_15_20190708_00028.jpg

View of spalling in bay 4. Summer 2019.

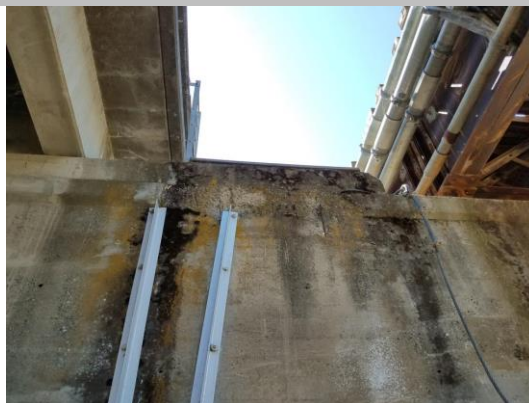
Photo 4 of 8 : ST_2019_NA0055_1_15_20190708_00033.jpg

View of exposed metal in bay 37. Summer 2019.

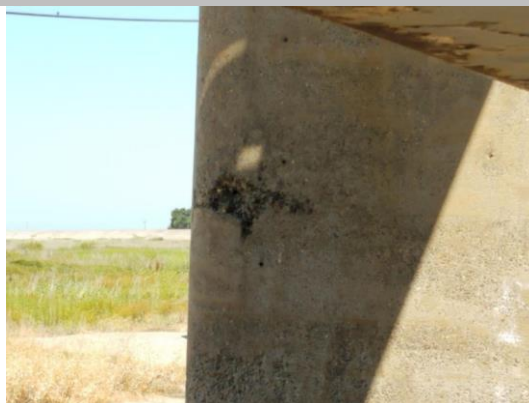
Photo 5 of 8 : ST_2019_NA0055_1_15_20190708_00034.jpg

View of spalling in bay 43. Summer 2019.

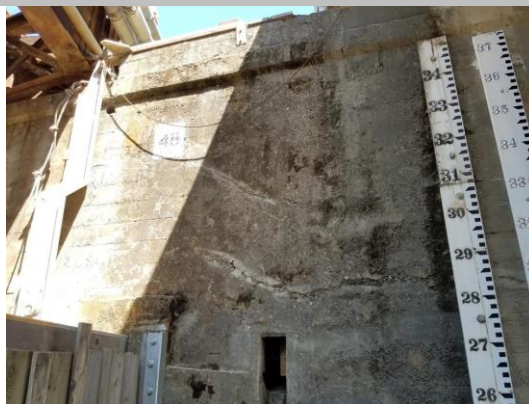
Photo 6 of 8 : ST_2019_NA0055_1_15_20190708_00035.jpg

View of cracking in bay 48. Summer 2019.

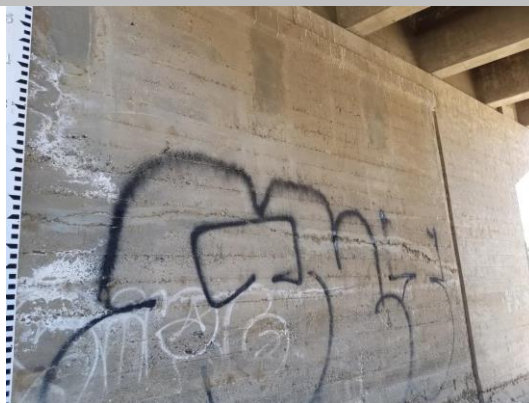
Photo 7 of 8 : ST_2019_NA0055_1_15_20190708_00036.jpg

View of cracking in bay 48. Summer 2019.

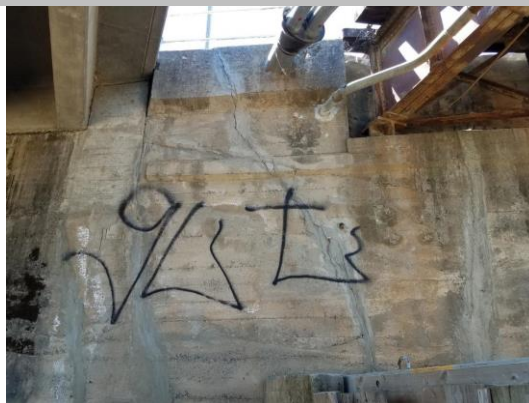
Photo 8 of 8 : ST_2019_NA0055_1_15_20190708_00037.jpg

View of cracking in bay 48. Summer 2019.
